ROAD SAFETY REVIEW

CATALINE ELEMENTARY SCHOOL

School District #27 (Cariboo-Chilcotin)
City of Williams Lake

November 9, 2016

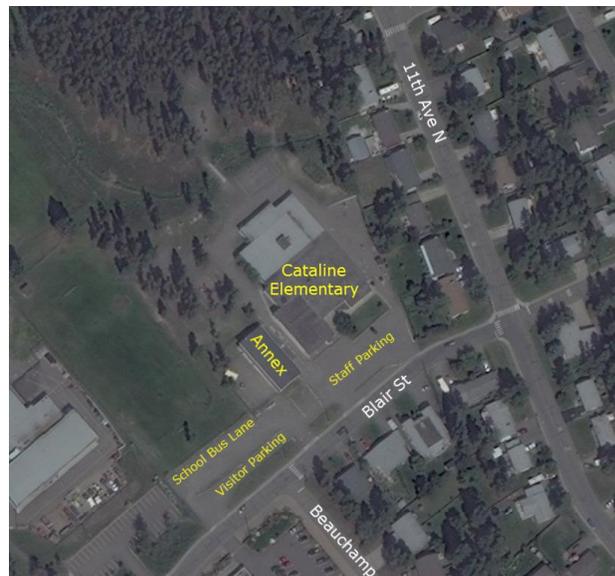
Cataline Elementary School Site

Cataline Elementary is located on the north side of Blair Street between 11th Avenue N and Beauchamp Crescent. Blair Street is an approximately 8.2 metres wide with a sidewalk provided on the north side. Stopping is prohibited on the south side of Blair Street during peak pick-up and drop-off times and parking is limited to 15 minutes on the north side adjacent the school. A marked and signed School Crosswalk is located on Blair Street at Beauchamp Crescent as well as on 11th Avenue N at Blair Street.

A 27 stall staff only parking lot is provided adjacent the south end of the school. This parking lot is also used as a pick-up / drop-off facility where parents queue in the middle of the lot in a westerly direction to actively pick-up and drop-off students. A 20 stall visitor parking lot is provided west of the staff parking lot. The north side of this lot is designated for a bus lane to accommodate the pick-up and drop-off activities of the school's nine buses.

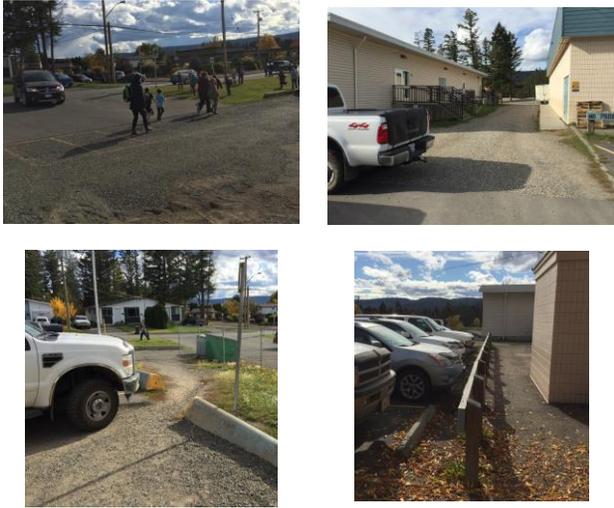
<p>The pedestrian connection from the west sidewalk includes a crossing of the Visitor Parking Lot entrance, through a gravel walkway between the Visitor and Staff Parking Lots, across the entrance to the Annex, and onto a pathway alongside the school building separated from parking spaces by a guardrail.</p>

- The walkway on the east side of the Staff Parking Lot is a combined pavement/grass surface, and
- The pedestrian connection from school entrance to Visitor Parking Lot is circuitous and of poor surface quality (discontinuous concrete and gravel).

- A sidewalk be installed along the east property line from the Blair Street sidewalk to the school entrance;
 - A sidewalk be installed between the parking lots from the Blair Street sidewalk to the school entrance; and

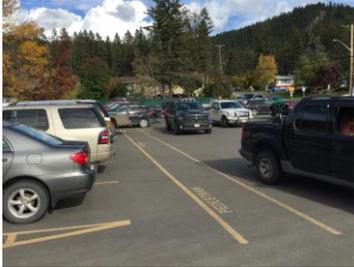
<p>The pick-up / drop-off facility located within the Staff Parking Lot consists of a painted pedestrian walkway behind parked vehicles that leads to a gap in the parking for pedestrian access to the school.</p>

Pick-up / drop-off activities are occurring in the middle of the Staff Parking Lot, with students getting out of the vehicles into the parking aisle. Without a formal facility with a receiving sidewalk and passing lane, haphazard movements are made increasing the risk of conflicts.

- A pathway be constructed from 11th Street N through the right-of-way to the school grounds.
- A pick-up and drop-off facility be constructed in front of the school adjacent a 3 metre (minimum) wide sidewalk that allows students to exit the vehicle on the passenger side onto the sidewalk that leads to the school entrance. Observations indicated that the size of this pick-up and drop-off area would not accommodate the existing demand, so a second facility is recommended in the west parking lot – again with a sidewalk providing a direct connection to the school entrance. Often a safe traffic management plan is developed for schools; one for Cataline Elementary could assign families with young students to the east parking lot facility, the rest could be assigned to the west lot.

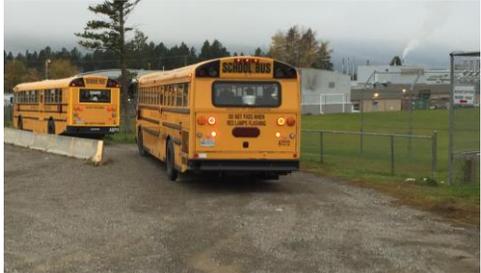
<p>The existing bus facility is located on the north side of the Visitor Parking Lot and is separated by concrete barrier. Gates are provided in the fence separating the bus lane from the playfield such that the gates line up with the bus doors when the buses stop. This allows the playfield to serve as a collection area for the students waiting for and getting off the buses.</p>

- The existing school bus facility should be relocated away from parking facilities and pedestrian activities. The proposed school bus facility to the north of the school provides safe one-way, counter-clockwise bus circulation to assure the loading/unloading of students occurs onto the provided sidewalk with a direct connection to the school without vehicle conflicts.

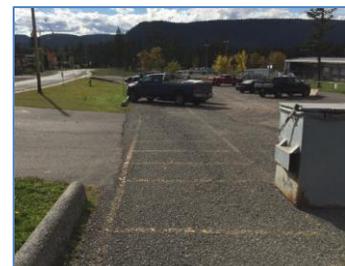
Parking Lot Crosswalk

The pedestrian crossing of Visitor Parking Lot entrance is set back from Blair Street in a non-typical location. This is mitigated during peak times due to number of students and staff monitoring, but awareness of crossing could be lacking during non-peak crossings. This is compounded due to a lack of lighting, a lack of pedestrian crossing signs and worn out paint markings.

Lighting is non-existent throughout both the staff and visitor parking lots, the bus loading area and all entrance crossings. This is an issue not only for students arriving early/late for extra-curricular activities in the winter season, but also for staff.

- The sidewalks on the bus loop also provide the pathway connection from 11th Street N to the school entrance without vehicle conflicts.
- With the bus stop relocated, the east and west parking lots could be designed as shown in Exhibits 1 and 2. Appropriate lighting should be installed to improve visibility during dark conditions.

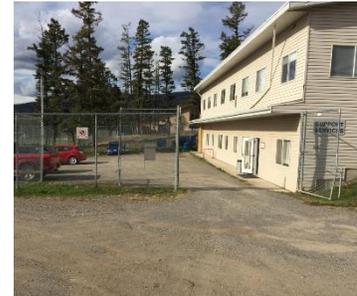
Support Services Access

The parking lot for the Support Services gains access from the Visitor's Parking Lot. This creates the potential for increased conflicts and a higher crossing demand of the entrance sidewalk. Exiting vehicles from the Support Services parking lot were observed exiting from the Visitor Parking Entrance.
